New Zealand Society for Earthquake Engineering

## THE CANTERBURY EARTHQUAKES:

### Answers to critical questions about buildings

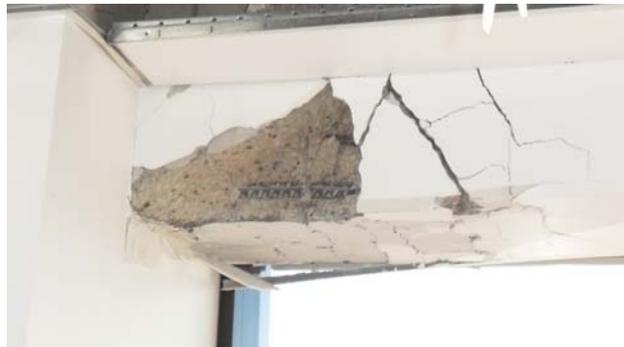
*Figure 1: An energy absorbing (ductile) beam hinge in a reinforced concrete building after an earthquake. As these ductile elements yield they absorb energy without loss of strength that would lead to collapse of the building. While some of the cover has fallen off, none of the reinforcing has broken, and the concrete inside the reinforcing cage is intact, so this beam can still carry load.*

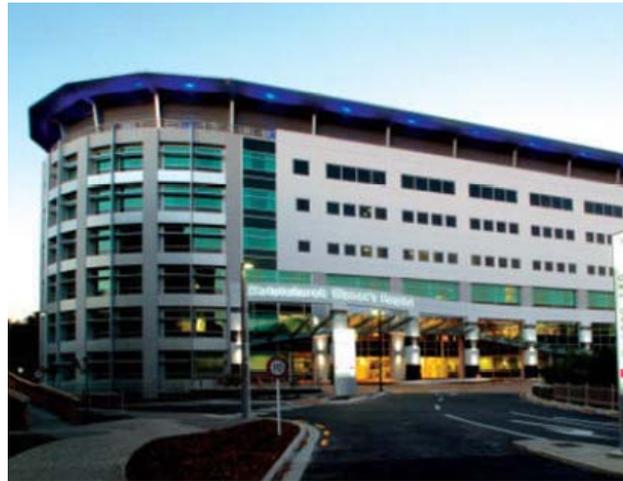
Figure 2: Christchurch Women's Hospital sits on Lead Rubber base isolators.

Lead rubber bearings, as deployed at Christchurch Women’s Hospital (Figure 2 & 3), Parliament and Te Papa, are an example of a novel device developed by the former NZ Department of Scientific and Industrial Research in order to protect structures against severe ground shaking. This is called base isolation, because it allows the ground to move horizontally beneath the building thereby isolating the structure from the ground and significantly reducing the forces on the building. Te Papa’s base isolators can be seen as a special exhibit just around the corner from the museum’s main entrance.

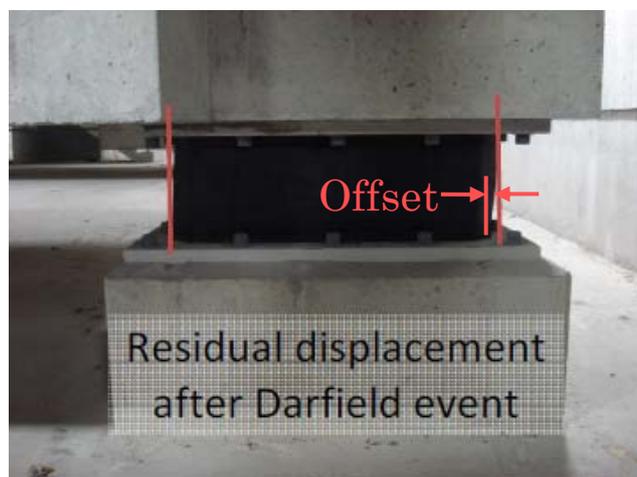
Figure 3. Lead Rubber base isolator under Christchurch Women's Hospital, showing the final resting position of the building after its oscillation during the 4 September 2010 earthquake.

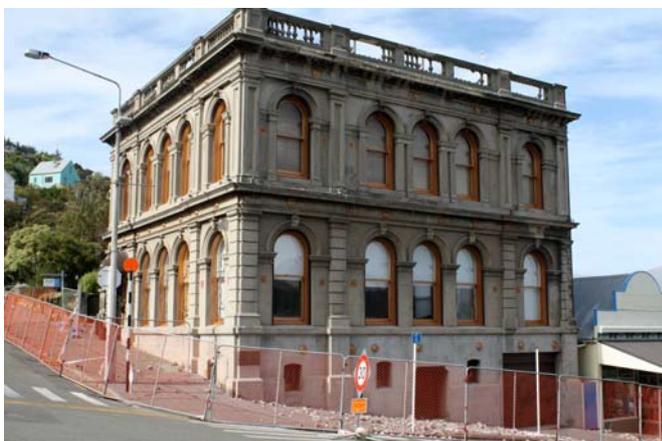
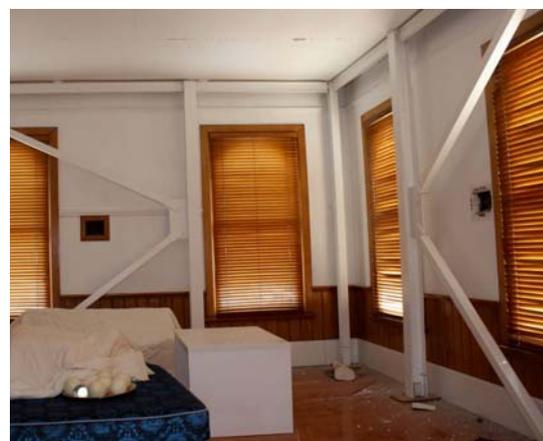
*Figure 4: The Lyttelton Fire Station building suffered only minor damage as it has been strengthened with an internal steel frame (Photos Win Clark)*

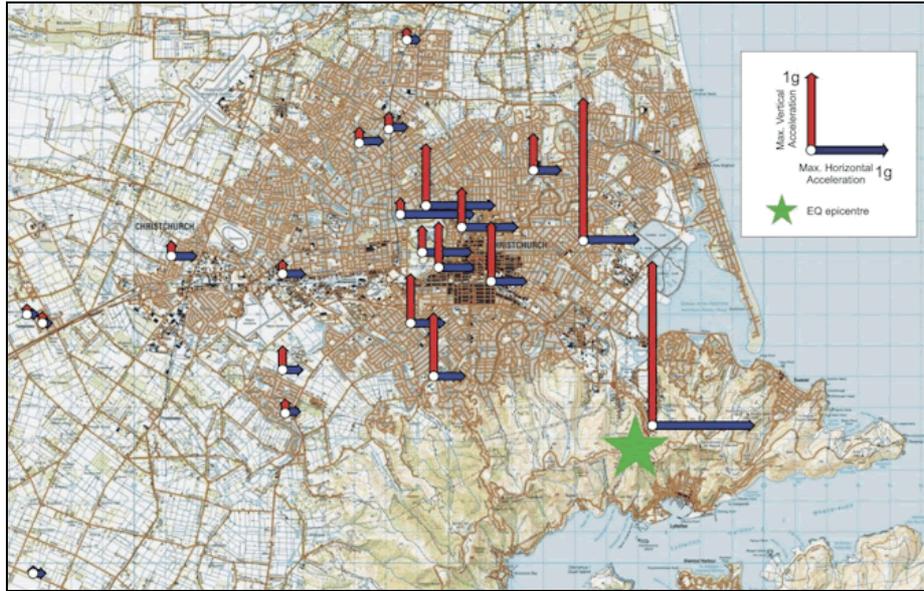
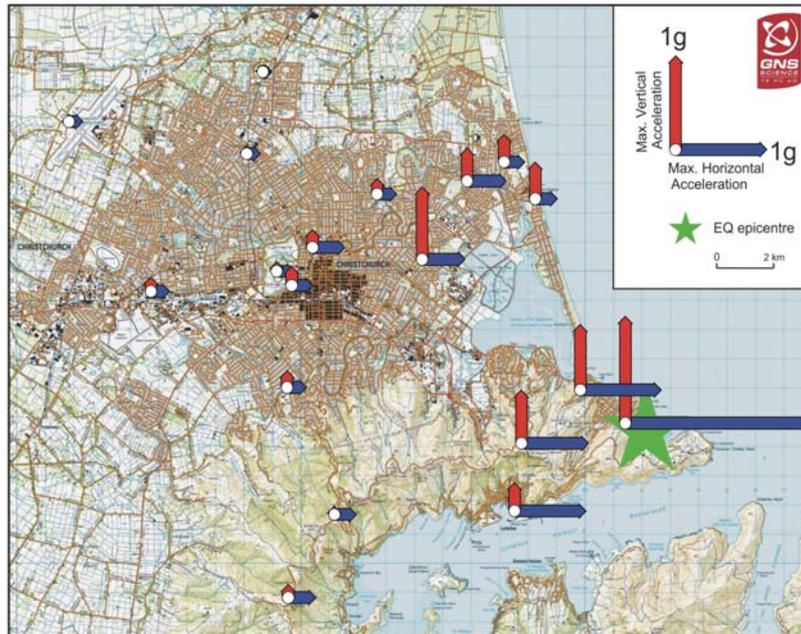
*Figure 5a and 5b: Graphic showing the unusually high vertical ground accelerations in central Christchurch recorded during the magnitude 6.3 earthquakes on 22 February and on 13 June 2011. (Source: GNS Science)*

Despite being only 6.3 on the earthquake magnitude scale, the proximity of the 22 February and 13 June 2011 events to the surface, and to Christchurch, caused ground shaking in the central business district several times as severe as what occurred in the magnitude 7.1 September 2010 earthquake (Figures 5a and 5b). The geology of the area made matters worse by guiding the shock waves towards the city. The peak ground accelerations, as they are called, were amongst the highest to have ever been recorded in a modern city anywhere in the world.

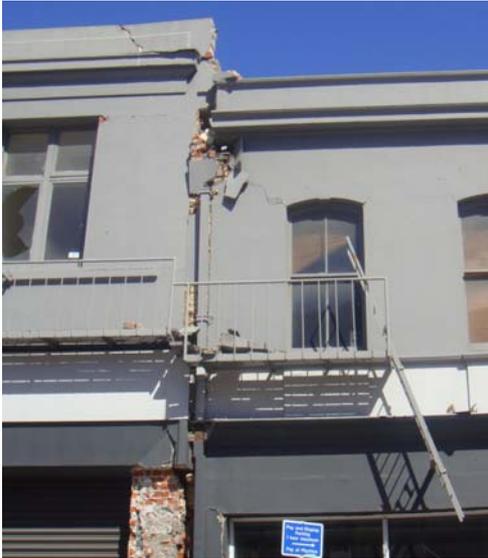
*Figure 6: Pounding-induced damage of buildings in Christchurch CBD<sup>3</sup>*

Other ways earthquakes cause damage to buildings include when two adjacent buildings collide as the ground movement makes them sway, causing pounding damage (Figure 6), or when sometimes, parts of one building—like parapets, chimneys or façade veneers—fall on another building and cause damage.

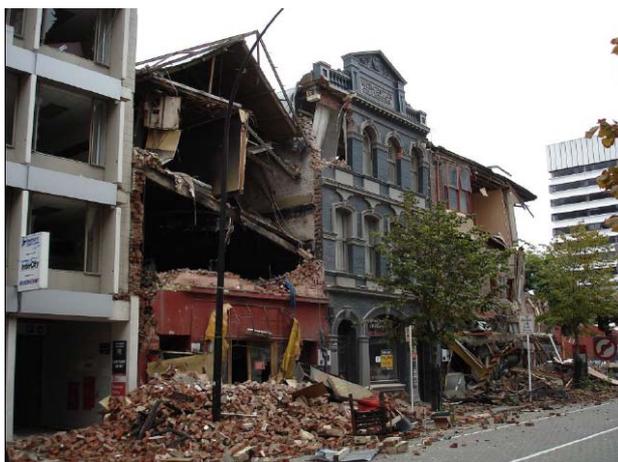
Figure 7. Former earthquake prone buildings.

Every Territorial Authority is required under the Building Act 2004 to have an “Earthquake Prone Building” policy.<sup>4</sup> The measures in the legislation recognise that local economic, social and other factors have an impact on the implementation of these provisions of the Act. Christchurch City Council had estimated before the September earthquakes that, as defined in the Building Act 2004, there were potentially 7600 “earthquake prone” buildings in Christchurch; these are primarily commercial buildings constructed before 1976.

Those buildings identified as being at the highest risk of collapse were the approximately 960 unreinforced brick and stone masonry buildings, which are likely to fail in a moderate earthquake, although refurbishment and redevelopment for new uses has meant some of the buildings have undergone some level of strengthening. Christchurch City Council had also estimated there are around 490 heritage buildings that are earthquake-prone as defined by the Building Act; the majority (295) are unreinforced masonry, but also 29 reinforced concrete, and 163 with timber-frames or of other types. The Christchurch City Council, in an extraordinary meeting on 10 September 2010, adopted its revised Earthquake-prone, Dangerous and Insanitary Buildings Policy.<sup>5</sup>

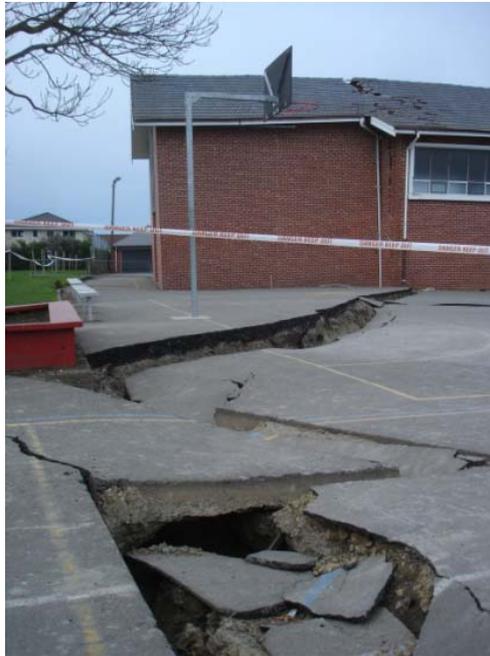
*Figure 8 Lateral spread crack running through the courtyard and building at St. Paul's church, Dallington, Christchurch, New Zealand (September 2010)<sup>6</sup>*

Most buildings did not collapse even though the levels of earthquake shaking were up to about twice the design level for buildings meeting the current code requirements. Even buildings in areas of liquefaction and lateral spreading, as well as strong shaking, did not collapse despite some being badly damaged (Figure 8) or left tilting.

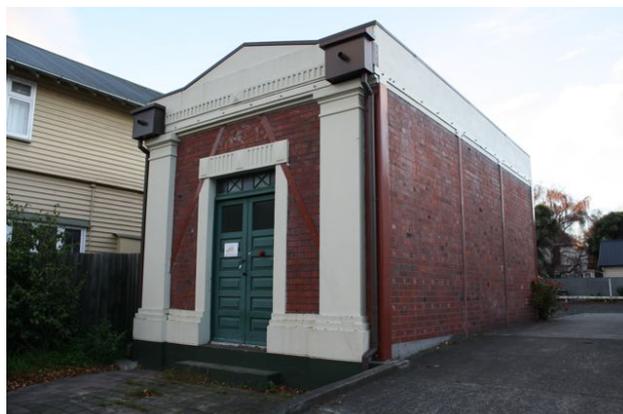
*Figure 9: Orion Local Substation. Constructed in unreinforced brick masonry that has been strengthened with a steel perimeter frame (Photo Win Clark)*

Just because a building is constructed in brick or stone, it is not necessarily a danger. If brick masonry is properly attached to a backing frame, as it is in most residential construction, it can behave well as can masonry blocks filled with concrete and strengthened with steel rods. Brick masonry restrained by a concrete or steel frame, if properly designed, can also behave well and it has been used effectively throughout the world, including Christchurch, as shown in Figure 9.
